2025 **ISPO CONFERENCE**  
DUBAI | UAE | NOV 27 - 28

**Promoting Safe Navigation  
Through Collaboration**

# Overview of Seaspan Operations

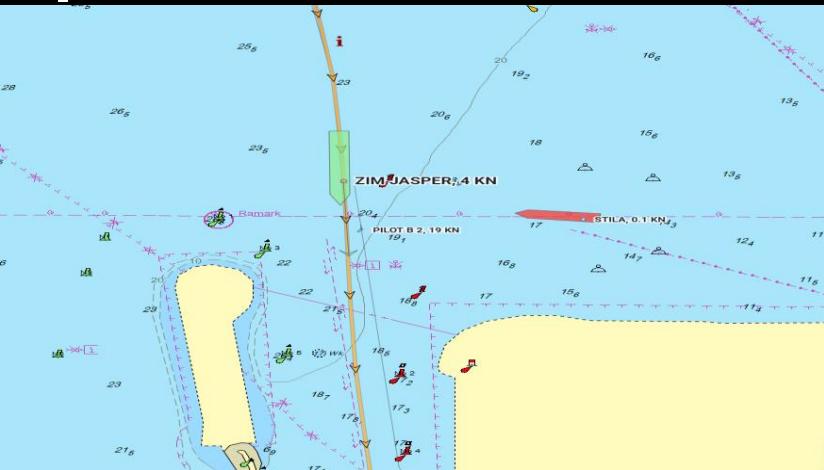
- High Speed approach (Longitudinal)

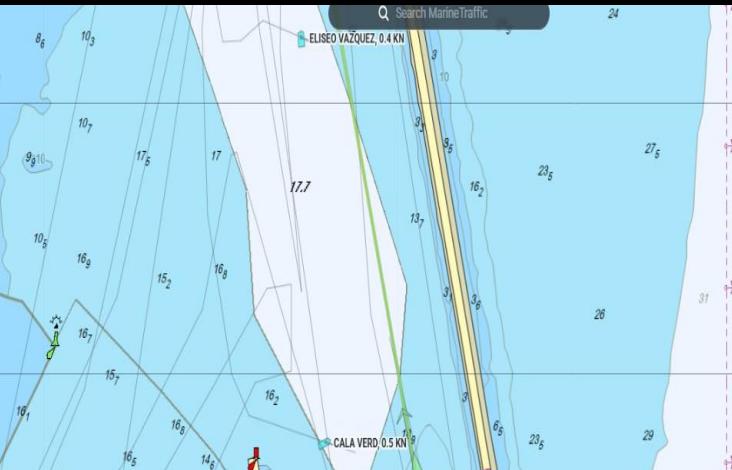
- Berthing with angular approach but not parallel

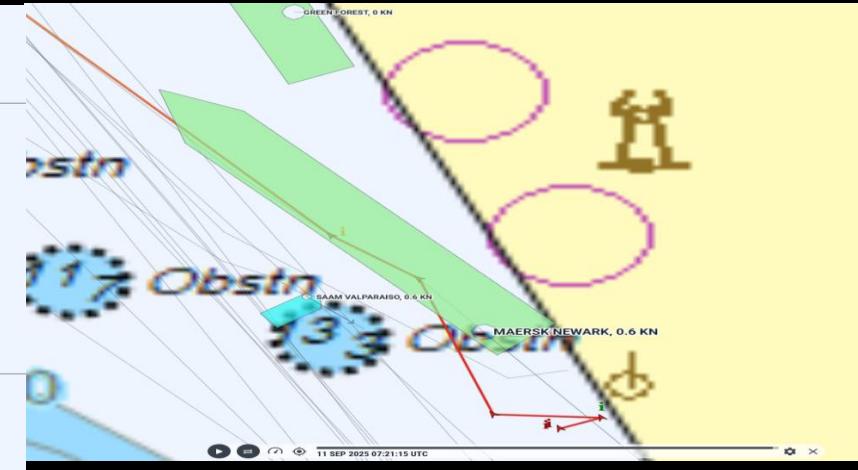
- Tugs not arriving in time

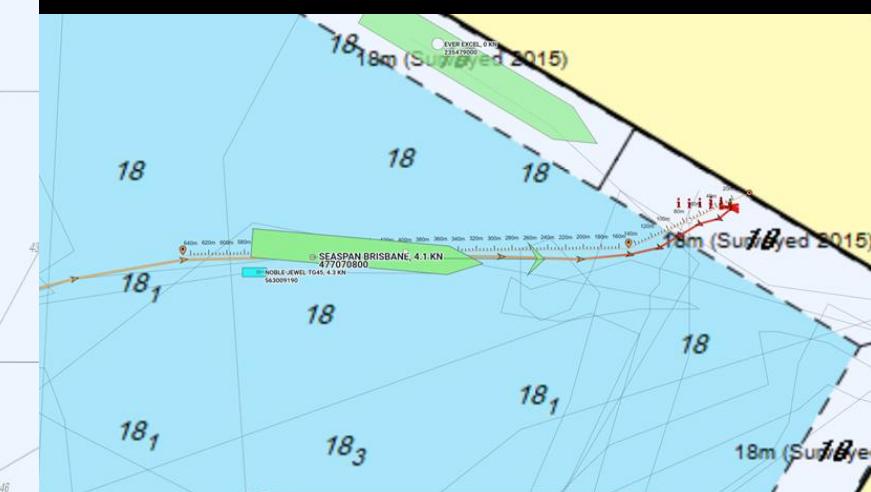
- High Speed approach(Lateral)

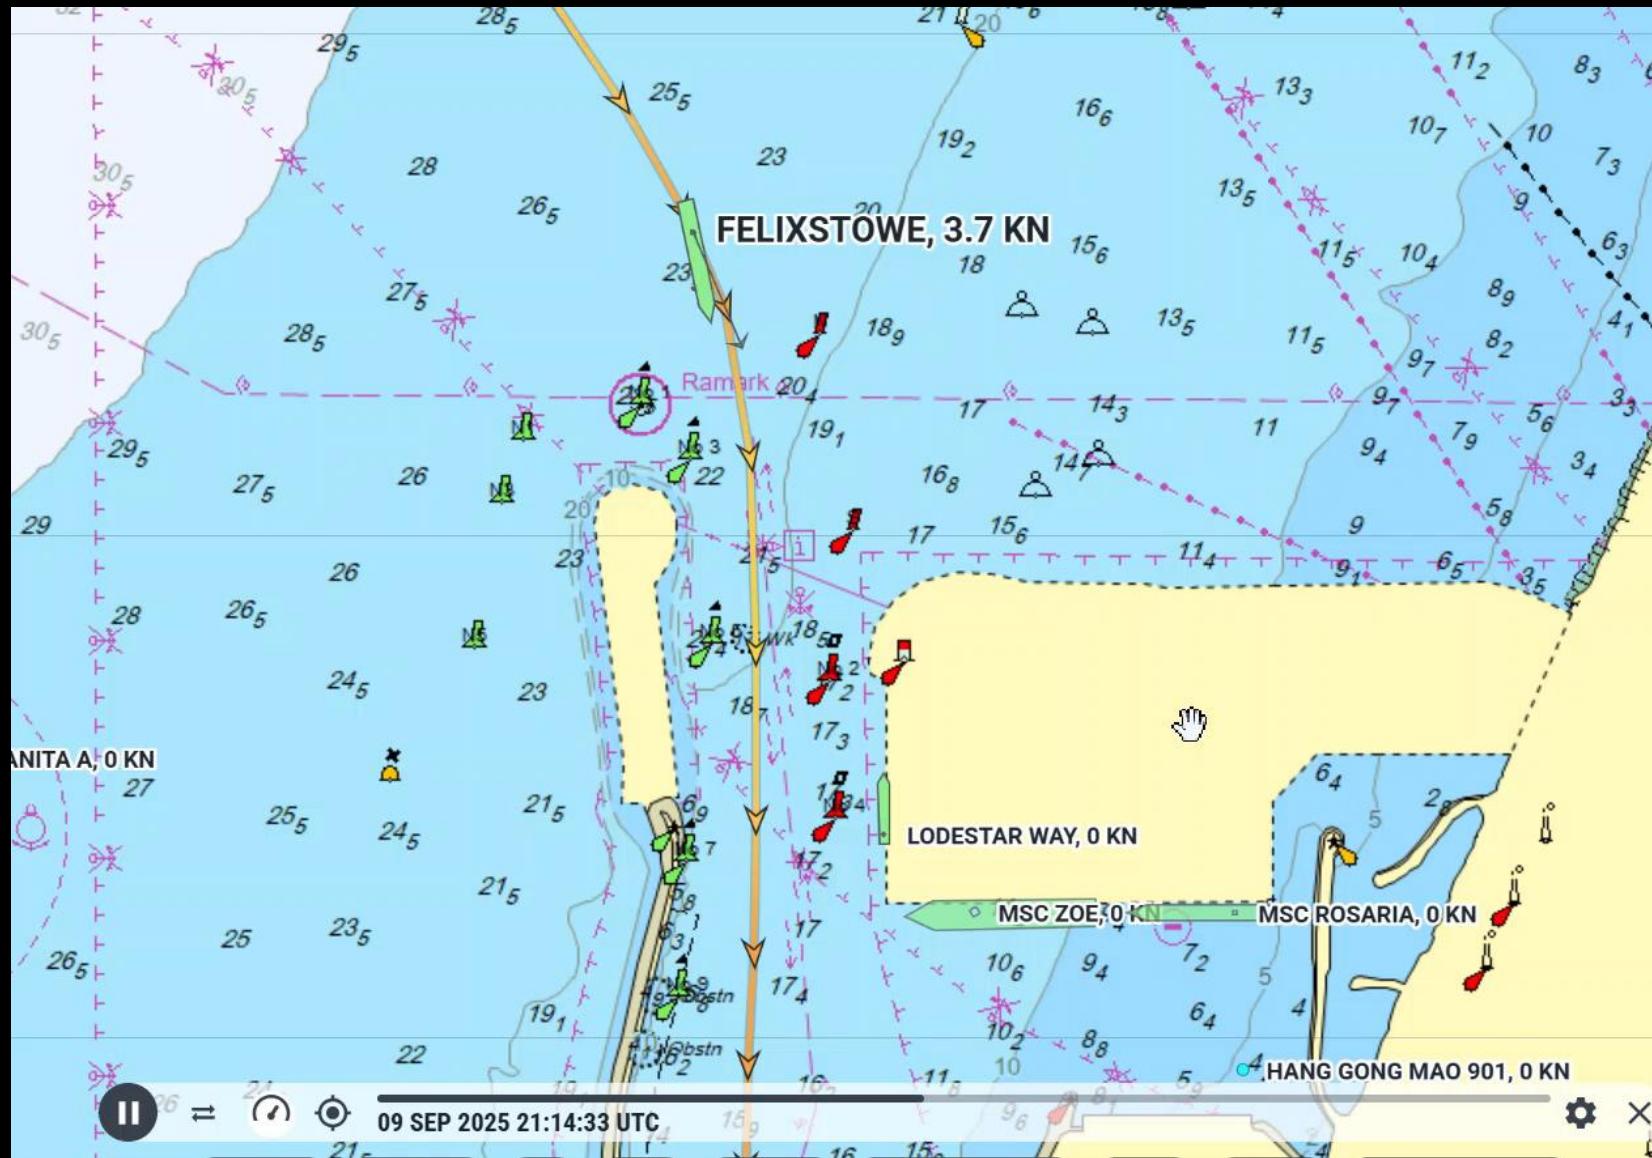
- Vessel picked up pilot inside the break water from outbound ship.
- Both vessel's momentarily without pilot inside the break water.
- No tugs fast
- Crossed abort point without pilot

- Engagement with Ashdod Pilots
- Masters advised to hold ground and not cross the pilot boarding point.

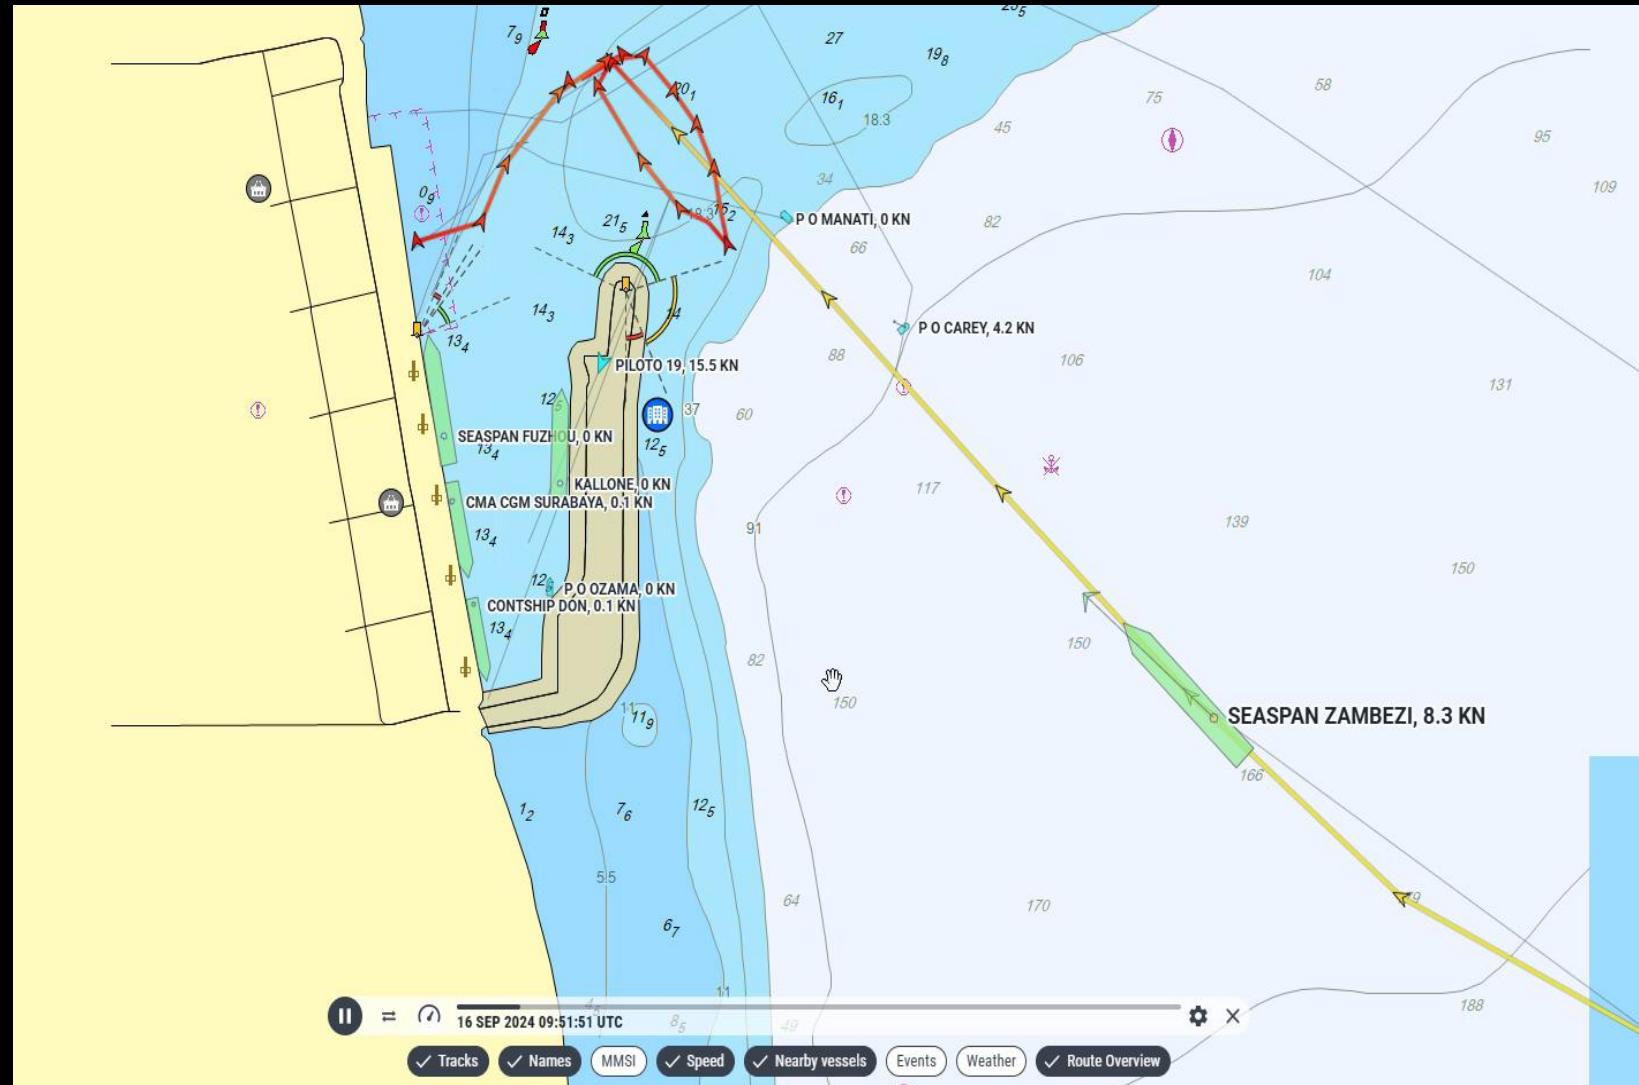
# Findings and corrective actions: Arr. Caucedo-Pilot not boarding at PBG-High speed approach-Soft Grounding

- Pilot not boarding at PBG
- High speed approach
- Tugs not fast in time
- No time for MPEX due to late pilot boarding
- Vessel not able to execute turn led to soft grounding

- Engagement with Caucedo port/Pilots.
- Enquired about delayed pilot boarding.
- Master briefed to comply with company's guidance on approach speed

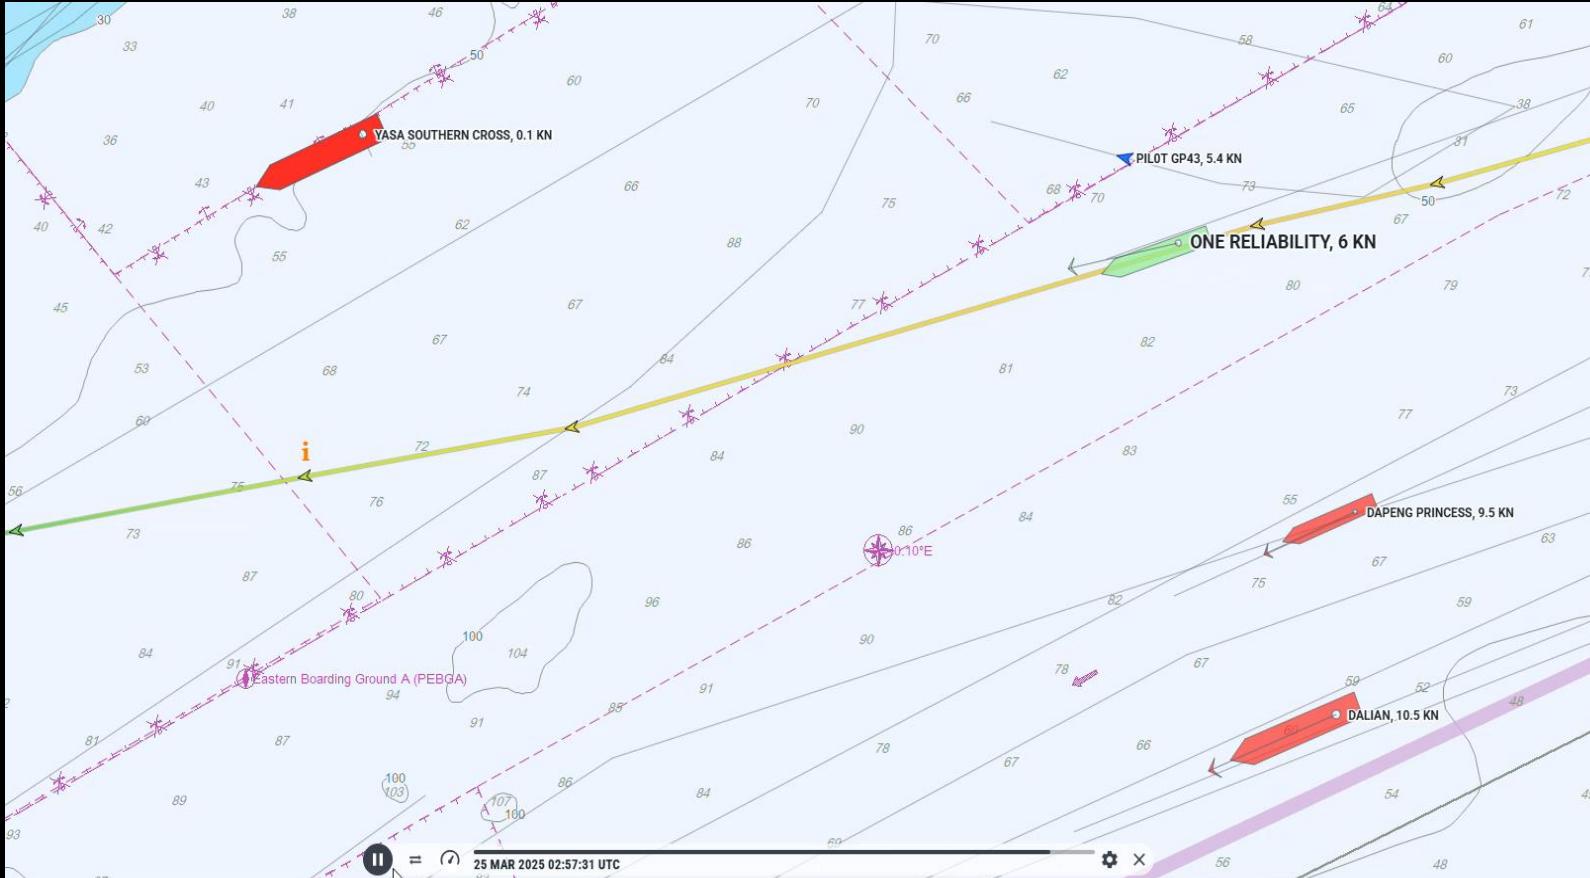
# Findings and corrective actions: Arr. Singapore-vessel went too close to land/shallows and carried out evasive maneuver

- After Picking up pilot, vessel proceeded north of the track very close to land/shallows and carried out evasive maneuver in Singapore straits TSS, by cutting across the separation zone and joined wrong direction of traffic flow and cutting across the separation zone again to join the correct direction of traffic flow .
- Similar approach was observed for other Seaspan vessels too.
- Non-compliance with COLREGS and Lack of situational awareness.

- Engagement with MPA Singapore
- Investigation of maneuver in progress by MPA Singapore.

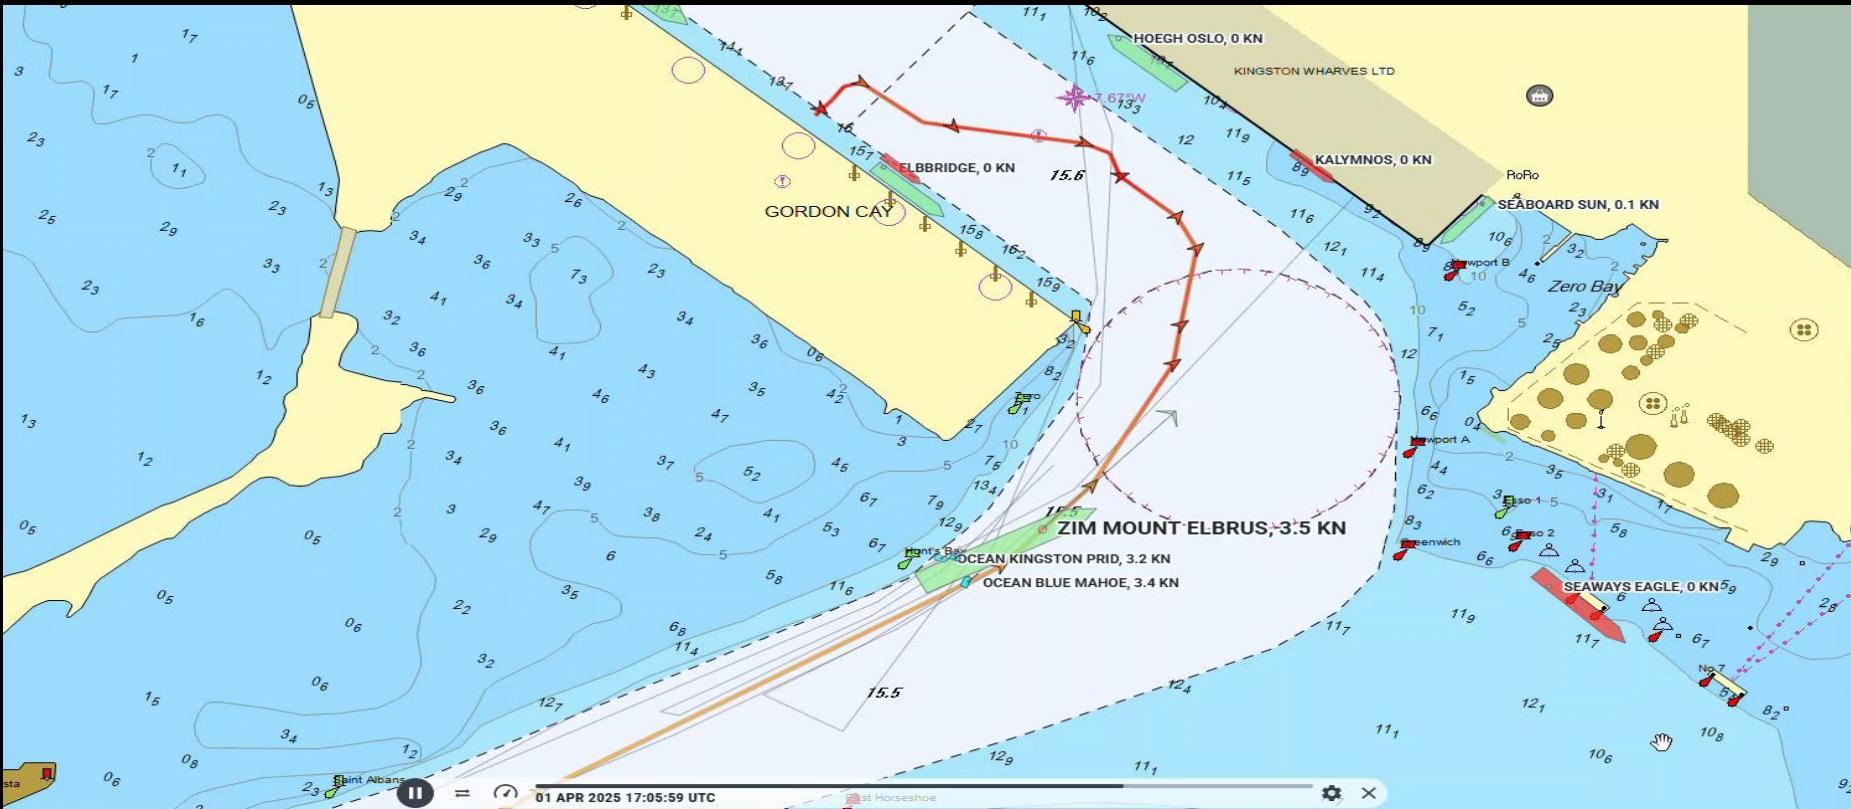
Arr. Kingston-Incorrect positioning in turning basin-Strong SE'ly winds  
-close quarter with quay

- ZIM Mount Elbrus while approaching to turning basin with pilot onboard and 3 tugs made fast, she was positioned more on the port side rather than remaining centered in the basin.
- Strong Southeasterly wind of 30-35kts began to push the vessel towards jetty. Vessel came dangerously close to the quay and was very fortunate that no ship was berthed at the pier.

- Engagement with Kingston port/Pilots.
- Enquired about maneuver-Pilots

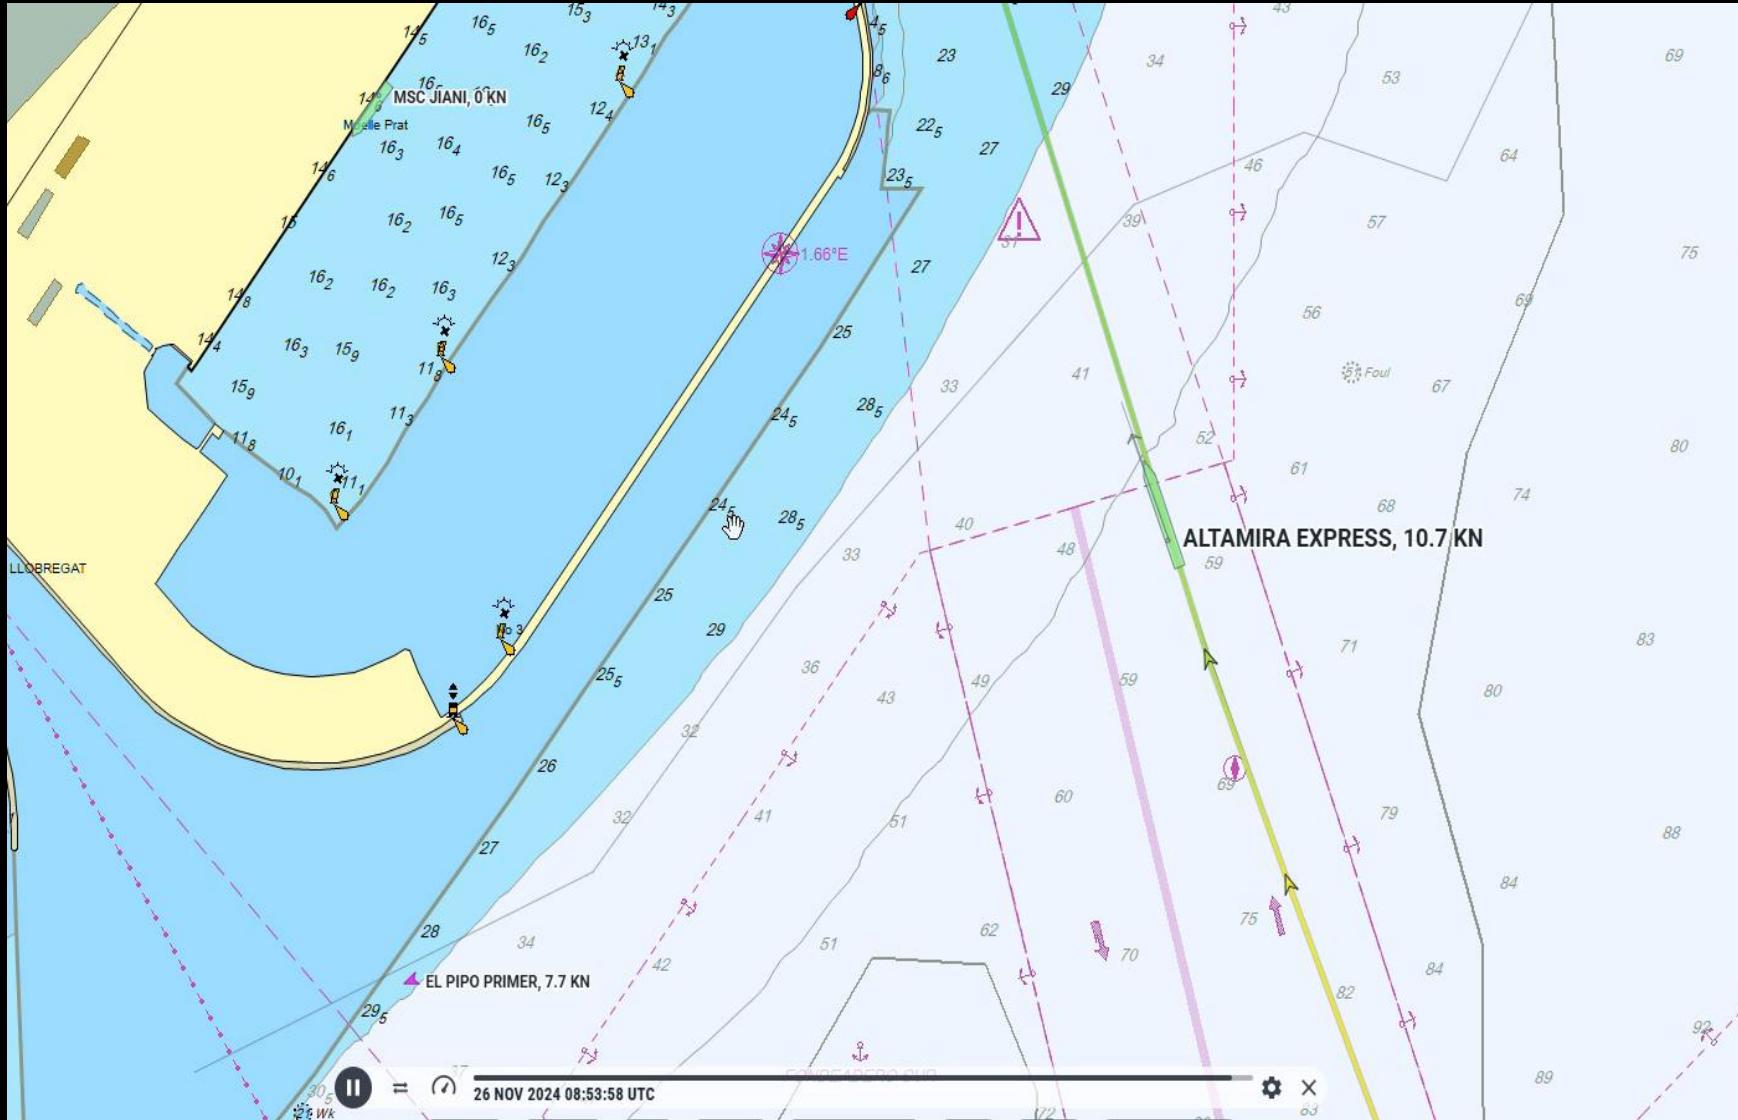
# Findings and corrective actions: Arr. Barcelona-High speed approach

- Very High-speed approach
- Entering Break water at 12kts
- Unable to make fast tugs due to high speed

- Master briefed to comply with company's guidance on approach speed
- Discussed associated risk of grounding/allision due to high speed

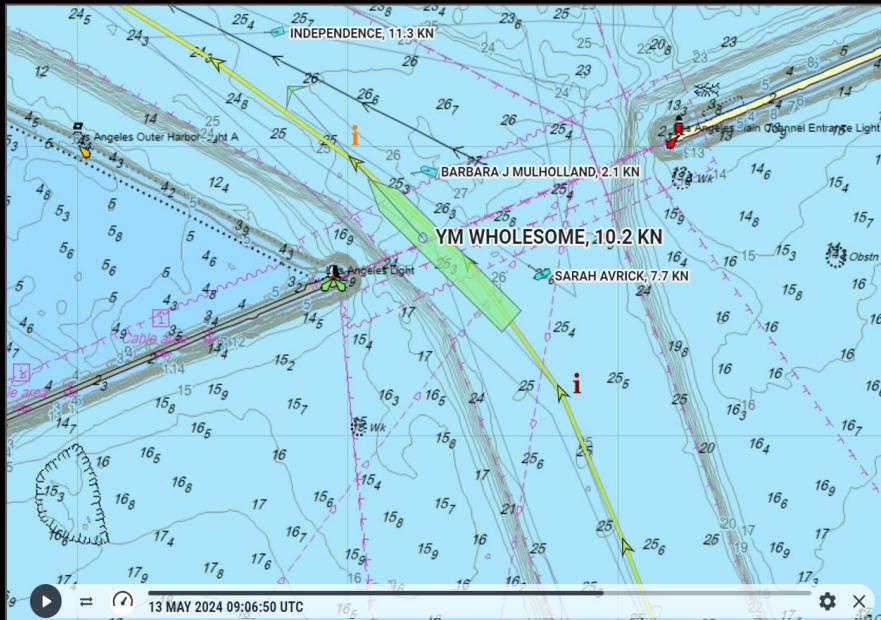
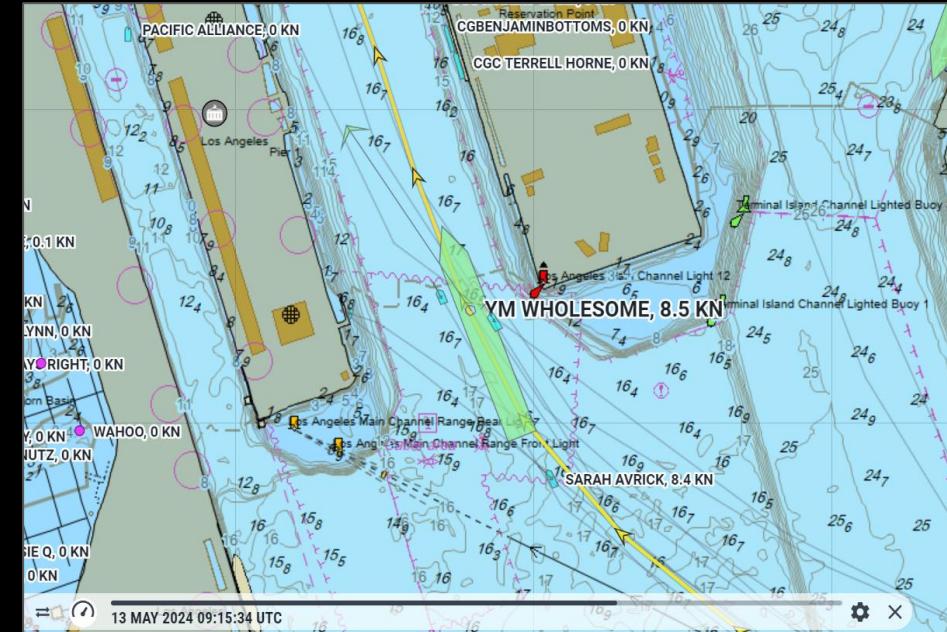
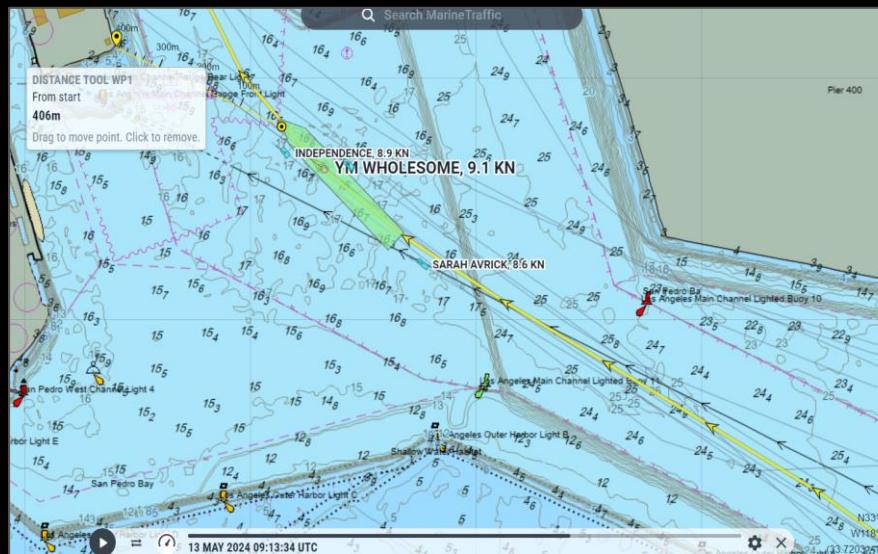
Arrival Los Angeles-High speed approach- Approx 400 m from the knuckle of the pier

- Vessel enters the breakwater at 10kts. Tugs approaching.
- Approx 400 m from the knuckle of the pier, speed 9.1 kts, with 3 tugs draft 14.9m. Astern power 20% of the ahead power.
- The vessel's highspeed maneuver within the break water, leaves very little margin of error for contingencies like blackout or steering failure
- Similar approach was observed for other large container vessels
- Loss of Engine Power: A vessel of 100000 Tons displacement, at 6 knots

- A meeting was held in person with Los Angeles pilots to discuss the matter
